# AVINOR NORWAY

AIP SUP  
39/2025  
25 JUN 2025

## ENAN - RWY, TWY and apron usage restrictions due to surface damage

Replaces AIP SUP 35/2025

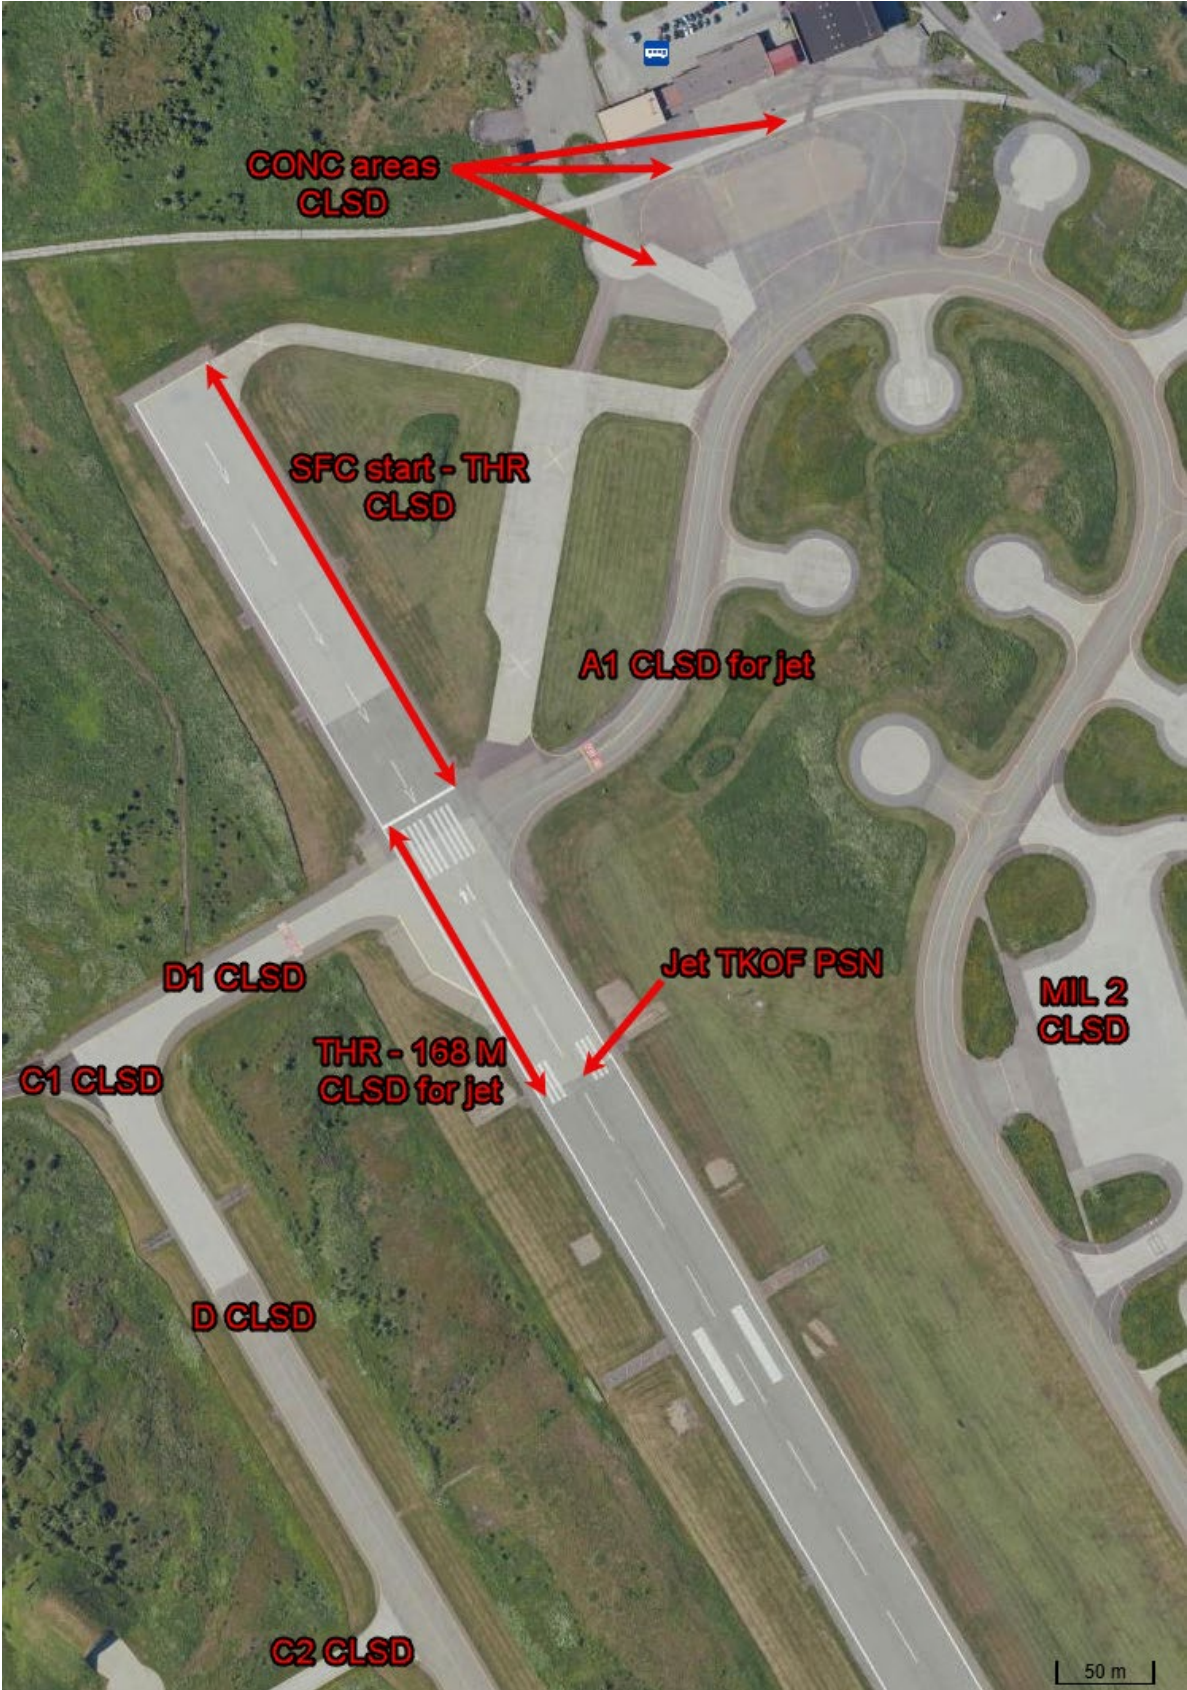
RWY 14

Due to surface damage, the first 168 M from THR 14 and the first 161 M from THR 32 are not suitable for taxiing and departure for jet engine aircraft.

Jet engine aircraft must be towed between the runway and the apron. This shall be coordinated beforehand with Widerøe Ground Handling station Andenes via e-mail [andenes@wideroe.no](mailto:andenes@wideroe.no). Arriving jet engine aircraft shall stop and shut down engines before the closed concrete surface by THR 14 to be towed via TWY A1. Departing jet engine aircraft will be towed via TWY A1 onto the runway and clear of the closed concrete surface by THR 14. Engine start may be expected after towing is complete.
